Murchison Decommissioning: Jacket Derogation Application

An assessment of proposals for the disposal of the footings of the disused Murchison steel jacket

MURDECOM-CNR-PM-REP-00005

18 November 2013

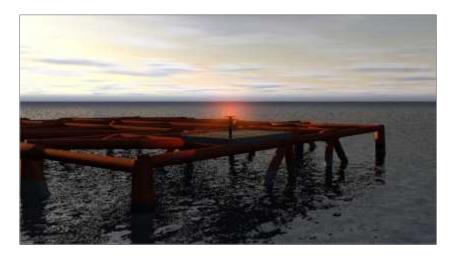
Figure 7: Jacket left in situ after removing topsides

The advantage claimed by stakeholders of leaving the entire jacket *in situ* with navigation aids above the surface of the sea, was as an aid to navigation particularly to those fishing vessels not equipped with the FishSafe marine plotter. The FishSafe system is designed to provide audible and visual warnings of surface and subsurface hazards.

The disadvantages identified by the Murchison Owners were the effect of accelerated corrosion and structural failure of the jacket members in the splash zone. Corrosion protection for the jacket is largely provided by an impressed current system supplied by the topside facilities. After the topsides are removed, the corrosion protection will be lost and corrosion rates will accelerate leading to progressive structural failure of those members subject to high wave slam loading in the splash zone. The resulting progressive collapse of the jacket to below the sea surface will lead to an increasing hazard to passing surface shipping.

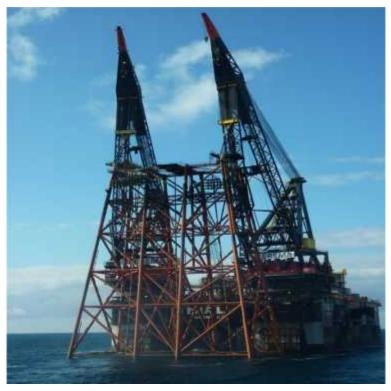
Figure 8: Jacket Removal using SSCV

In the North Sea decommissioning activities have been dominated by Heavy Lift Vessels (HLVs) with a capacity up to 5,000 te and the larger Semi-Submersible Crane Vessels (SSCVs) with a capacity of up to 14,000 te.

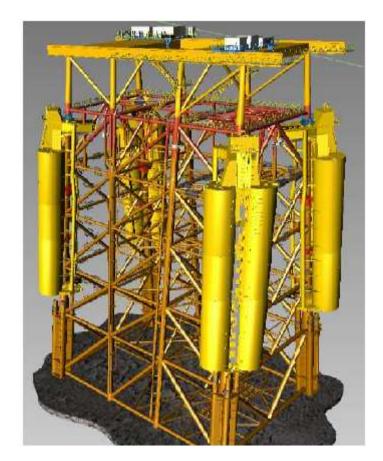
Figure 10: Jacket Removal using BTAs

Although not a vessel, Aker Kvaerner has developed a jacket removal method which uses external Buoyancy Tank Assemblies (BTAs) to refloat the jacket at a predetermined draft.

The BTAs were successfully used during the summer of 2008 to remove the 12,000 te Frigg DP2 jacket. With some modification the BTAs potentially could provide an alternate decommissioning option for the Murchison jacket and were therefore considered further in the comparative assessment process.

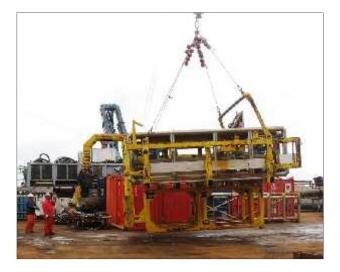
Figure 13: Diamond Wire Cutting Tool

The diamond wire cutting tool uses a wire impregnated with diamond beads. The wire runs around a series of pulleys and is rotated as it cuts through steel sections much like a chain saw.

For both the DWC and AWJ tools the main risks are associated with the reliability and verification of the cut and the safe handling and use of rigging equipment.

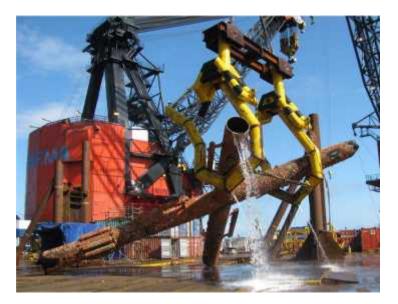
Figure 16: Section of Jacket Lifted Using Clamps

Rigging sets will be designed for each of the sections of the Murchison jacket to be lifted, and installed prior to the final cuts being made.

The rigging sets would have to be deployed positioned and attached subsea with some uncertainty on weight to be lifted and section profile caused by marine growth and the possibility of flooded members.

The failure of any part of the rigging sets could impact the lifting operation causing the jacket section being dropped back onto the remainder of the jacket, thereby making subsequent removal operations more complex. Of greater significance is the case where the jacket section being lifted is dropped onto the deck of the crane vessel causing injury to personnel on-board.
